CITY OF CAPE TOWN SURFACE STORMWATER SYSTEMS ZANDVLEI ESTUARY IMPACT ASSESSMENT

IMPACT ASSESSMENT ZANDVLEI ESTUARY NOVEMBER 2016

Prepared for Stormwater and Sustainability Branch (Planning Department – Transport for Cape Town) City of Cape Town

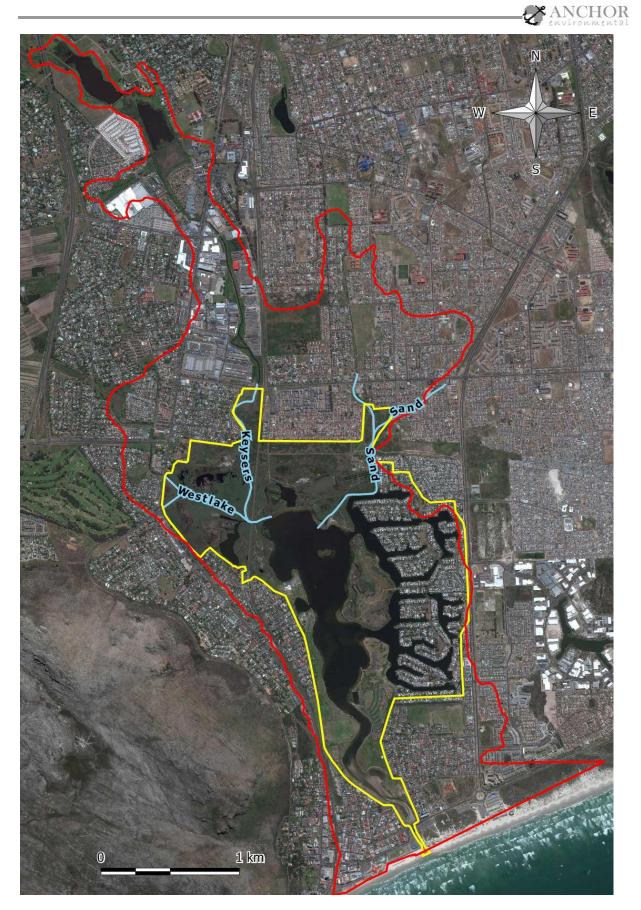
Figure 1. Spatial extent of the Zandvlei estuary defined for the purposes of this impact assessment Management Plan (yellow polygon) and the 5m contour (red polygon).

The Marina Da Gama canals constitute artificial estuarine habitat, but they are a connected and functioning part of the Zandvlei estuarine system. The CCT undertakes a number of maintenance activities within the canals, including pond weed management, maintenance of stormwater headwalls and outlets, erosion control of embankments alongside public open space, and may be required to undertake sediment management within the canals in the future. The Marina Da Gama Canals are therefore included in the definition of Zandvlei estuary extent for the purposes of this impact assessment (Figure 1).

The catchment of the Zandvlei estuary is approximately 92km² and bordered by Muizenberg Mountain, Silvermine Plateau and Constantiaberg to the West, Wynberg Hill to the North with a smaller, less noticeable eastern boundary. The main streams draining the catchment are the Westlake Stream, Keysers River, Langvlei Canal and the Sand River Canal (the latter essentially being the lower end of the Diep River). The Westlake and Keysers rivers converge and enter the northwest of the estuary via a reed filled wetland while the Langvlei and Sand rivers which flow in concrete canals converge and enter the estuary in the north-east (Figure 1).

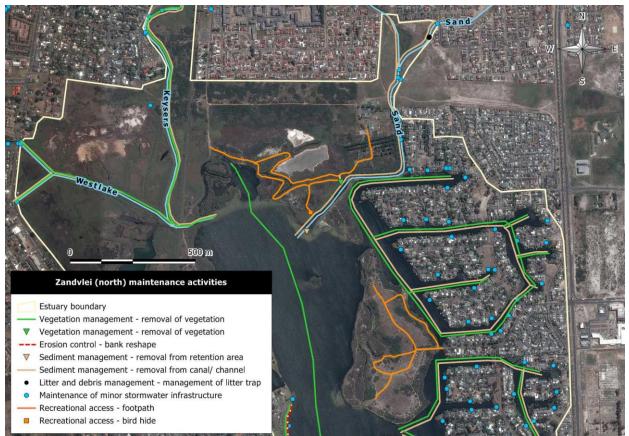
Figure 2. Location of required maintenance measures within the northern section of the Zandvlei estuary.
